DRAFT
FEDERAL ON-SCENE COORDINATOR'S REPORT FOR
THE WINDHAM ALLOYS SITE
WINDHAM, PORTAGE COUNTY, OHIO
SITE ID: B5E5
TDD: S05-0003-011
PAN: 0M1101RAXX
START DOCUMENT CONTROL NUMBER:

SUBJECT: ON-SCENE COORDINATOR REPORT- Windham Alloys Site, Windham, Portage County, Ohio, Site ID# B5E5

Removal Dates: 3/13/00 - 6/29/00

EXECUTIVE SUMMARY OF REMOVAL ACTIVITY

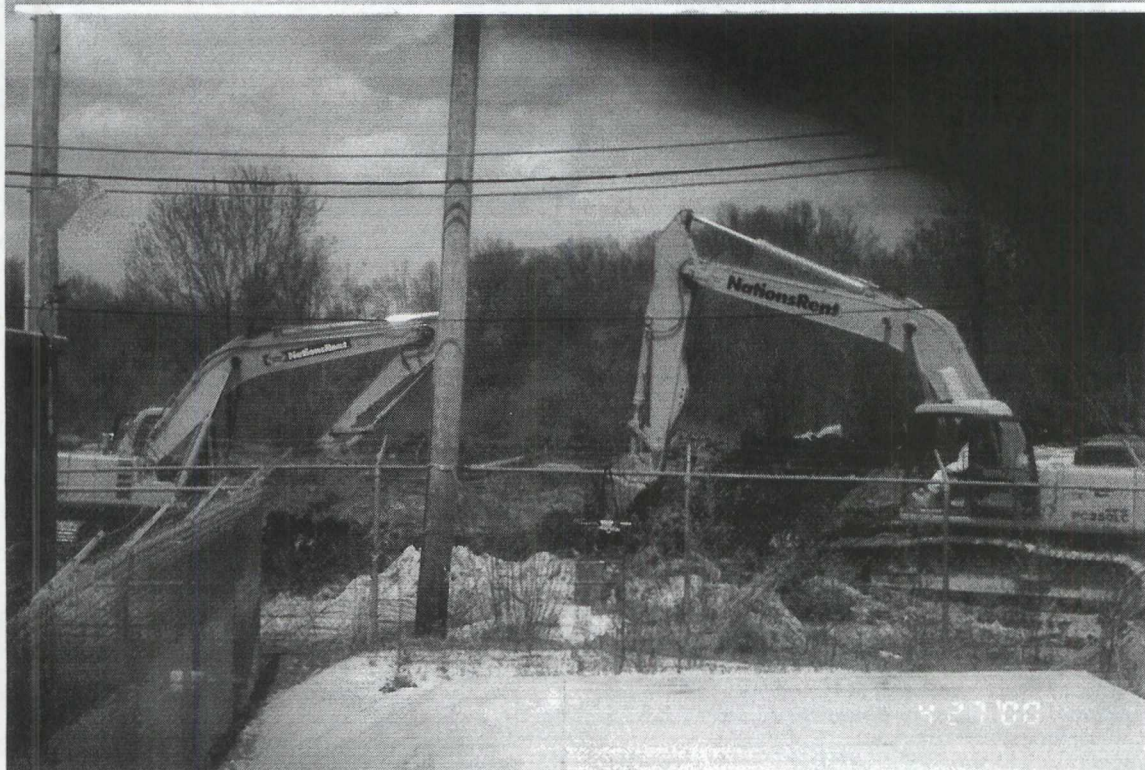
Description: This photograph shows the on-site treatment area utilized to mix lead and chromium-contaminated soil with cement kiln dust

Excavated soil and waste were treated on site to decrease the TCLP lead and chromium concentrations to nonhazardous levels. The lime and silicates within the kiln dust react in the presence of water to solidify the soil and therefore, decreasing the leachability of the lead and chromium. The treated soil and waste were then transported off-site as non-hazardous waste to be landfilled. Water collected on site was transported off-site for recycling. Table 6 contains specific disposal information for all waste streams.

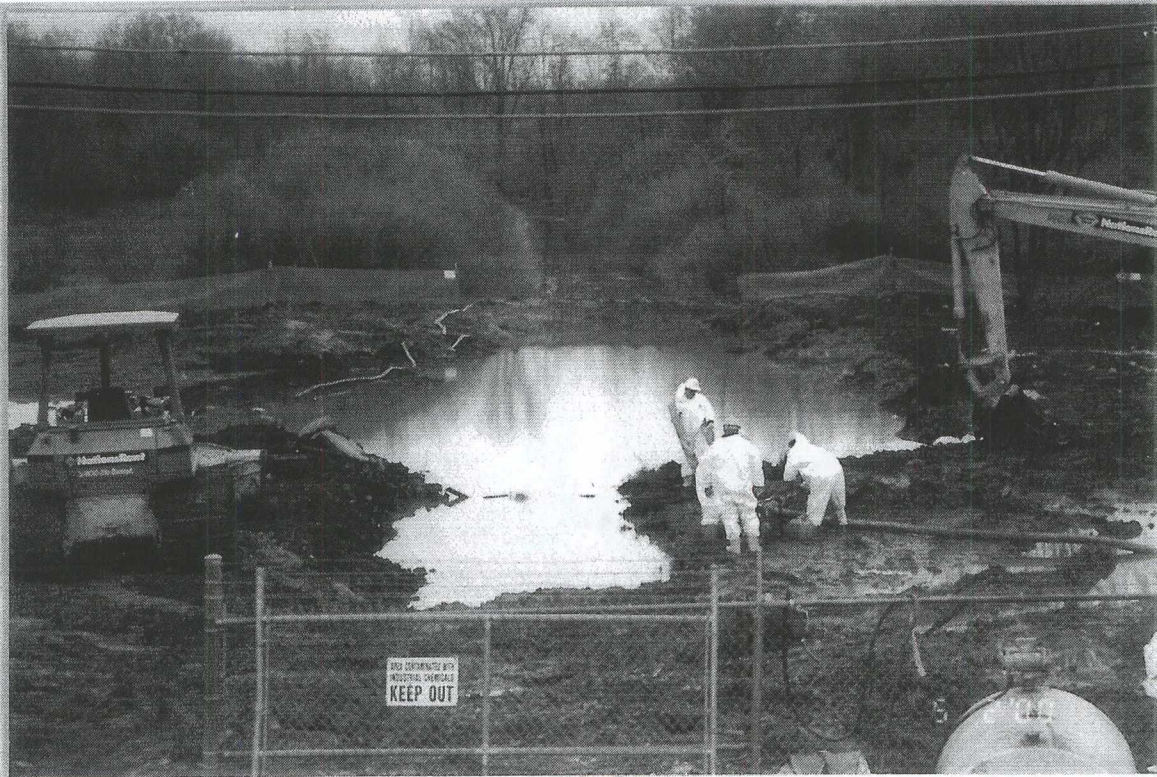
Description: This photograph shows ERRS pumping standing water from the on-site treatment area.

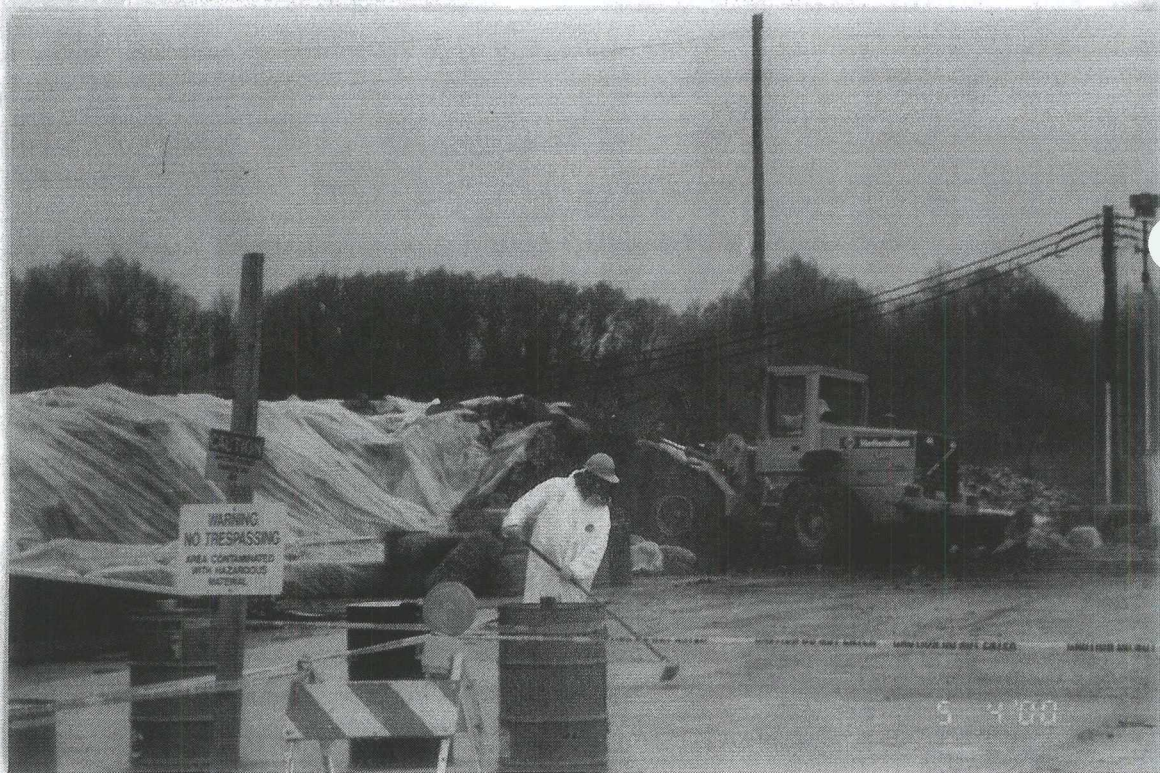
Description: This photograph shows a view of ERRS decontaminating the concrete pad in preparation for transportation and disposal of waste.

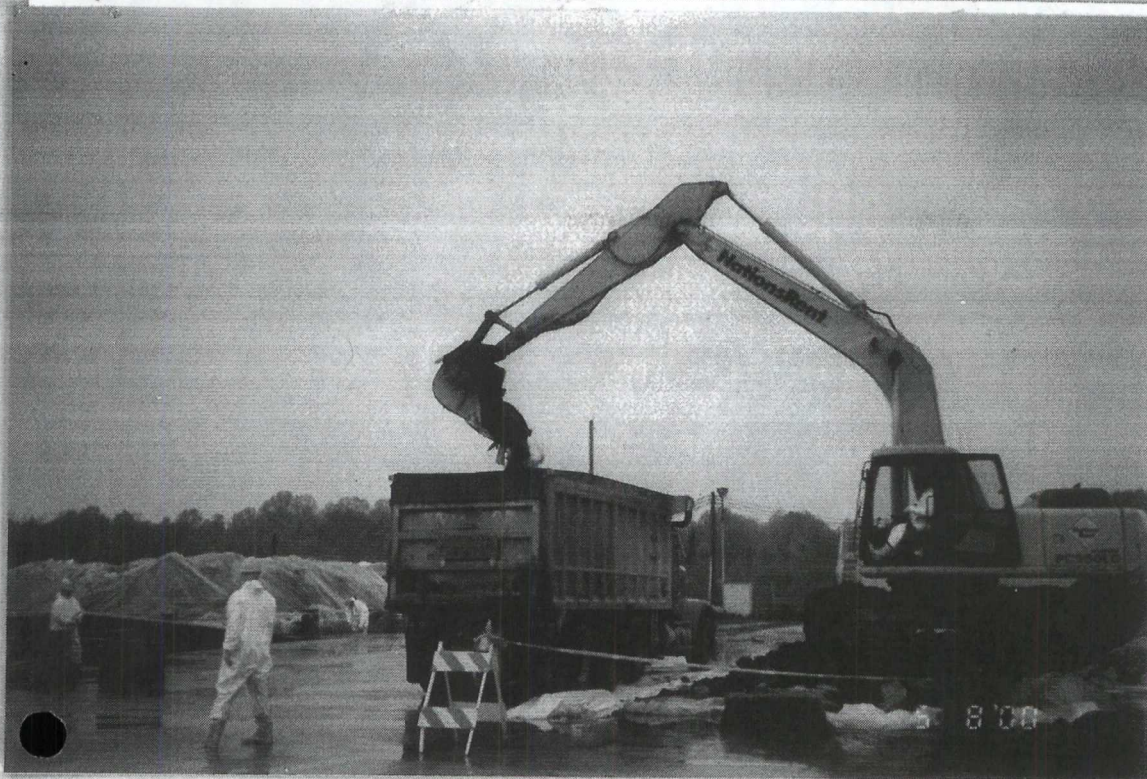
Description: This photograph shows ERRS loading treated soil into a truck for transportation off site for final disposal.

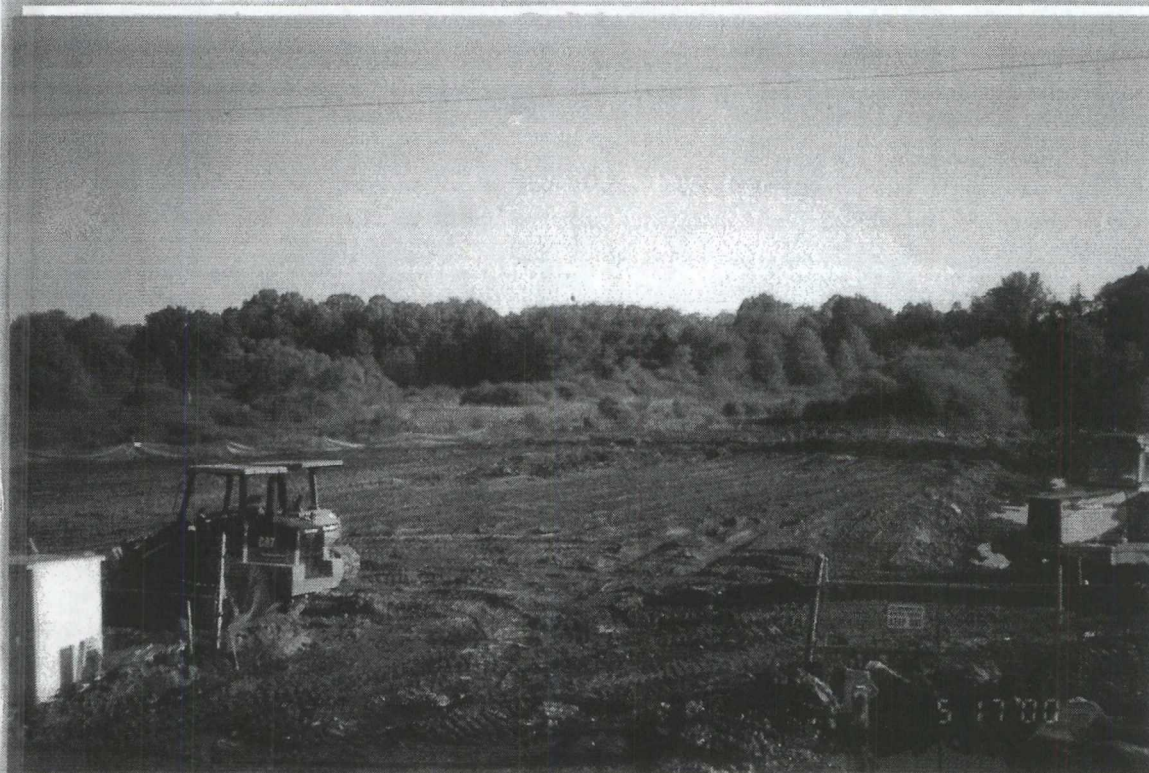
Description: This photograph show the main excavation area prior to the construction of the clay cap.

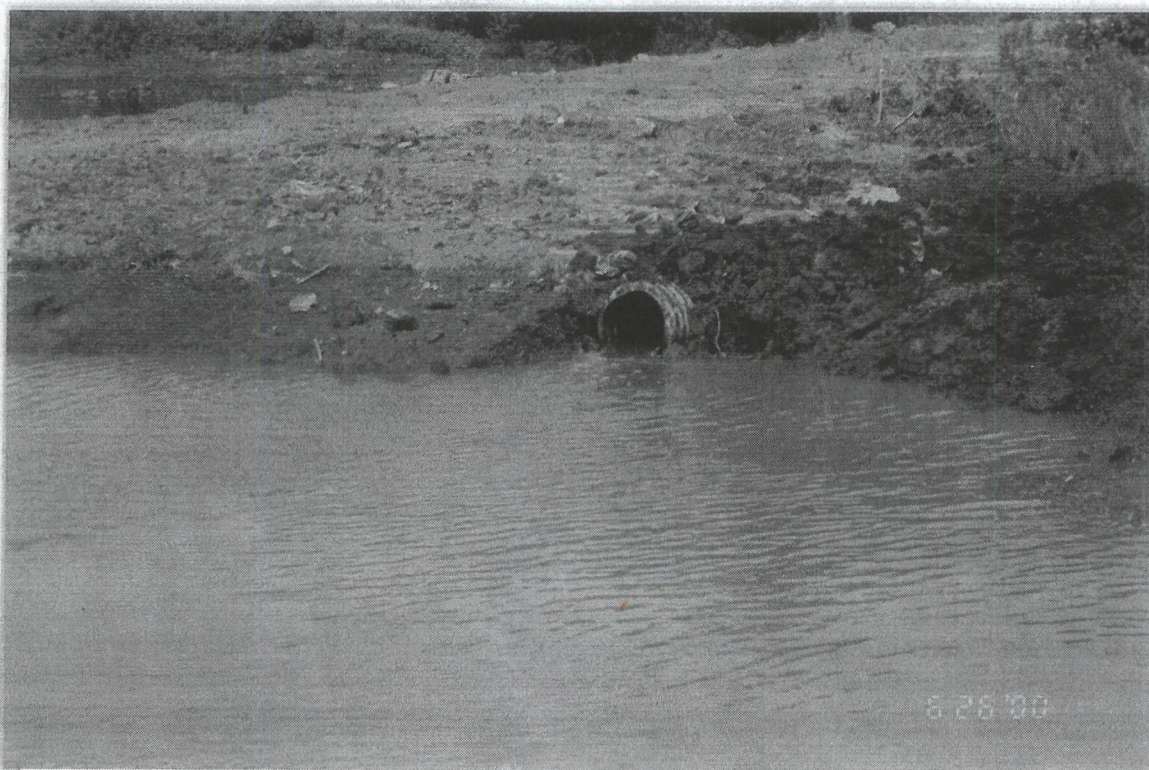
Description: This photograph shows reestablished drainage in the excavated areas.

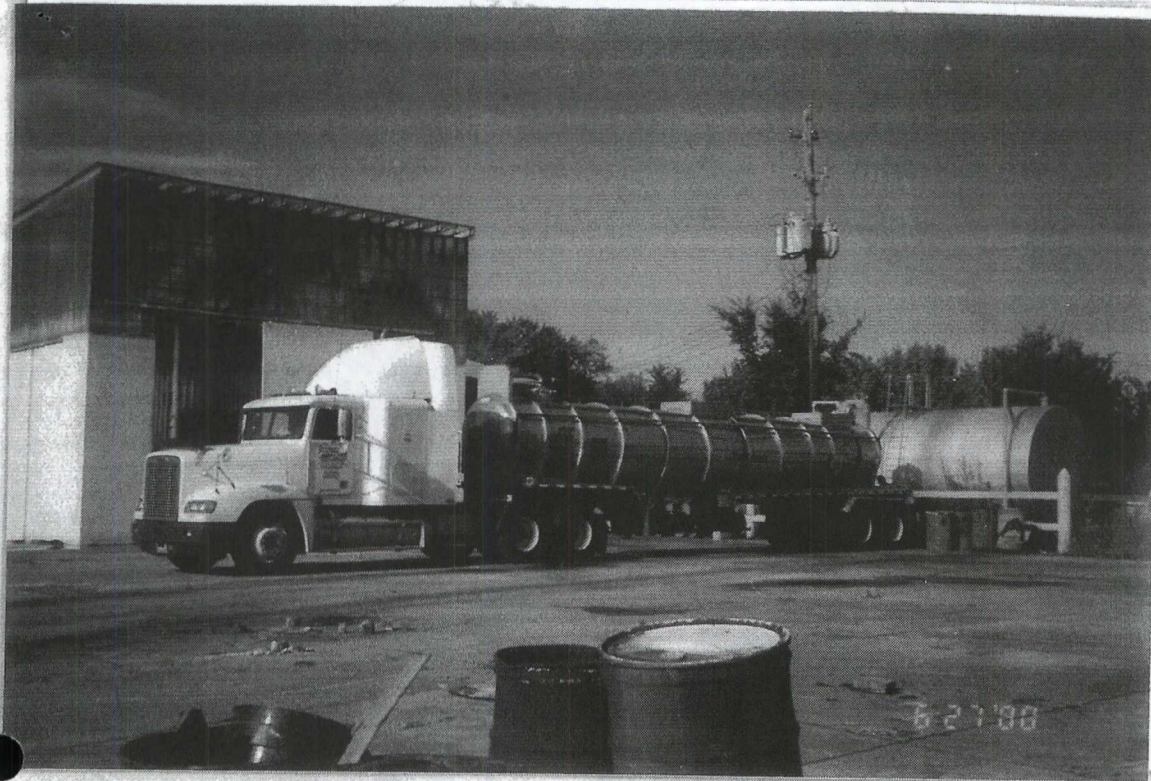
Description: This photograph shows the tanker utilized to transport hazardous liquid, removed for the on-site above ground storage tank, off site for final disposal.

ERRS removed approximately 12,870 gallons of hazardous liquid from the 15,000-gallon on-site AST. The liquid was transported off site to Petrochem, Inc., located in Detroit, Michigan for fuel blending. The piping to the AST were cut in order to decommission the AST.

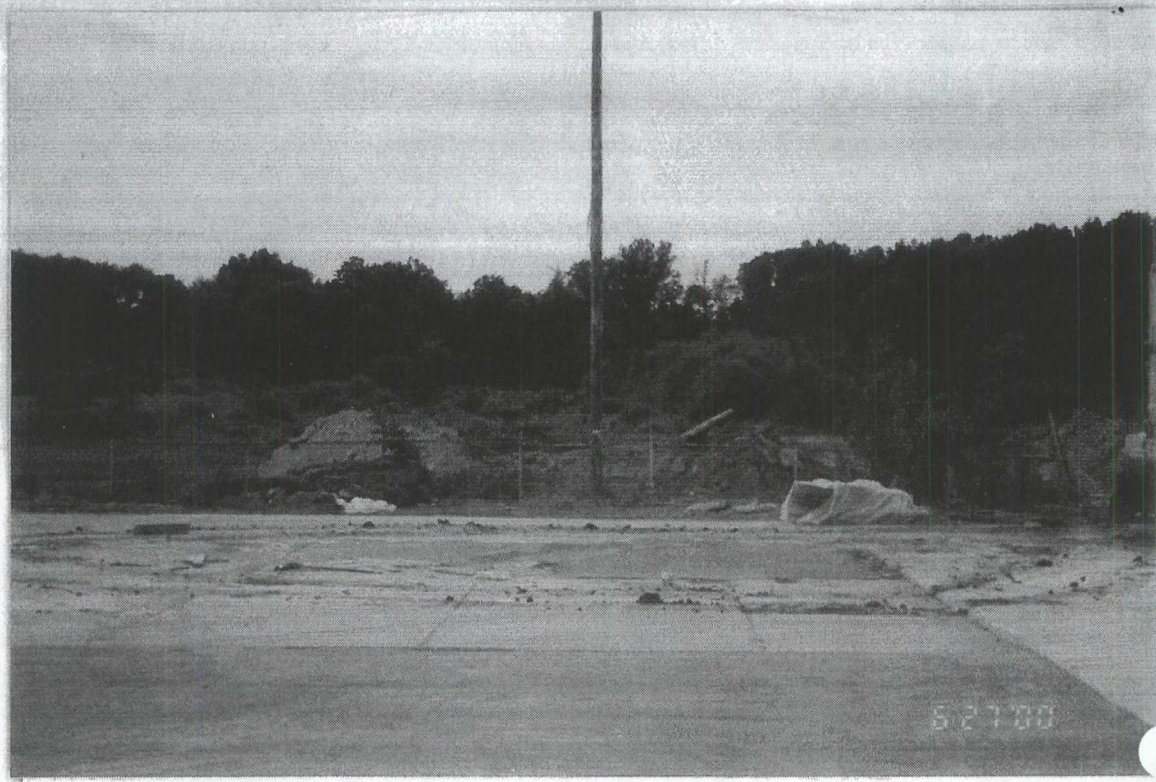
Description: This photograph shows the repaired concrete, which was damaged during removal activities.

Final site activities consisted of repairing a portion of a concrete pad damaged during removal activities. Off site gravel was mobilized to site to restore the gate entrance to the excavated areas.

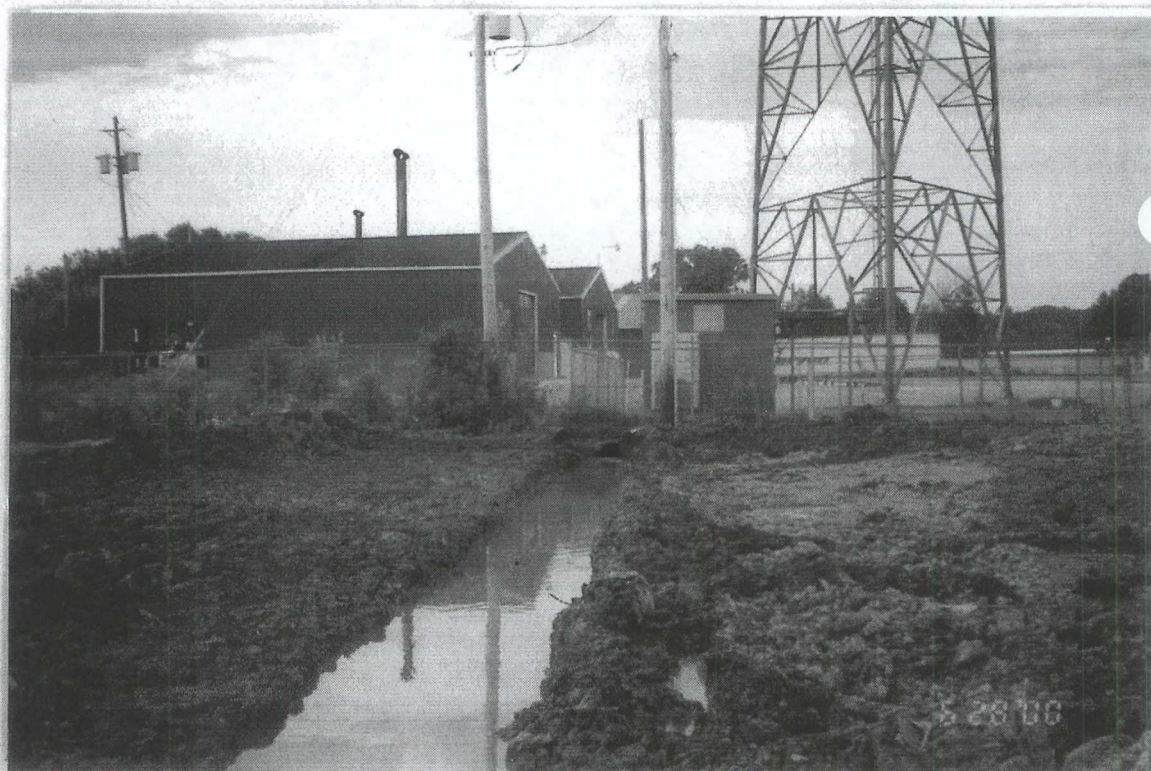
Description: This photograph shows reestablished drainage in the excavated areas.

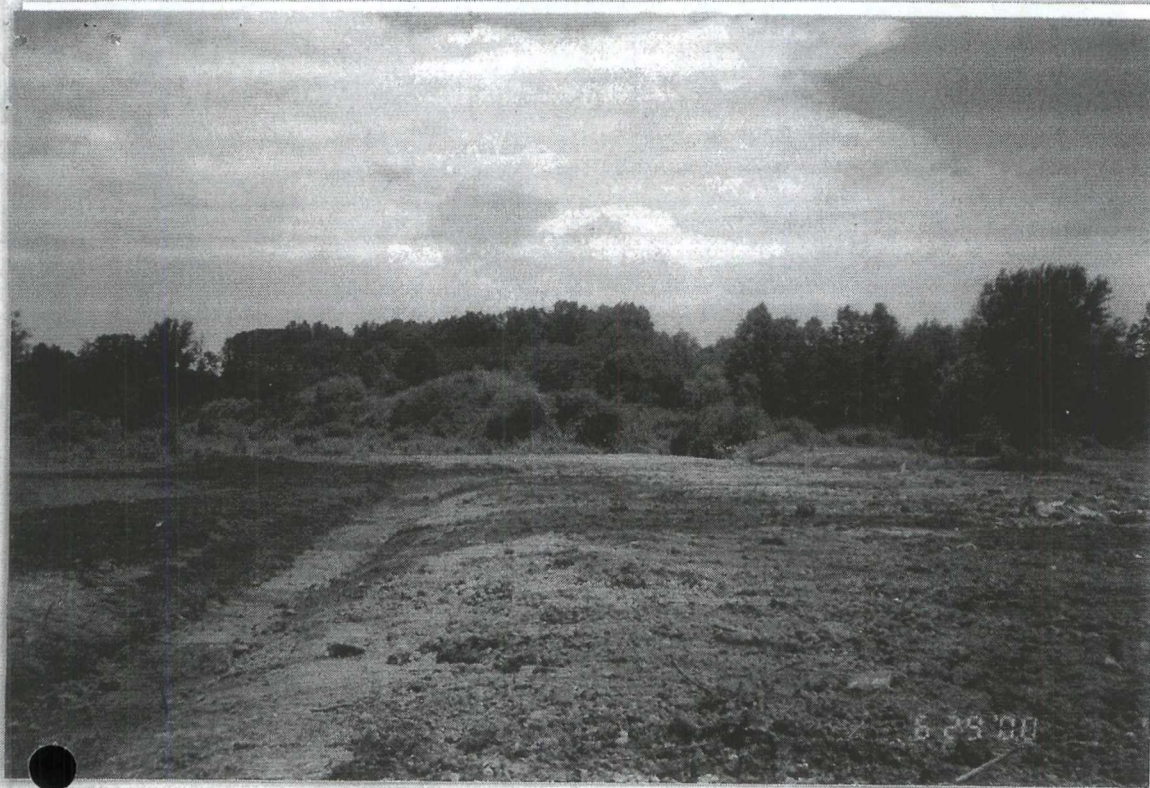
Description: This photograph shows the excavated areas after final restoration.
